LHCb-2008-049

# The LHCb Silicon Tracker: lessons learned (so far)

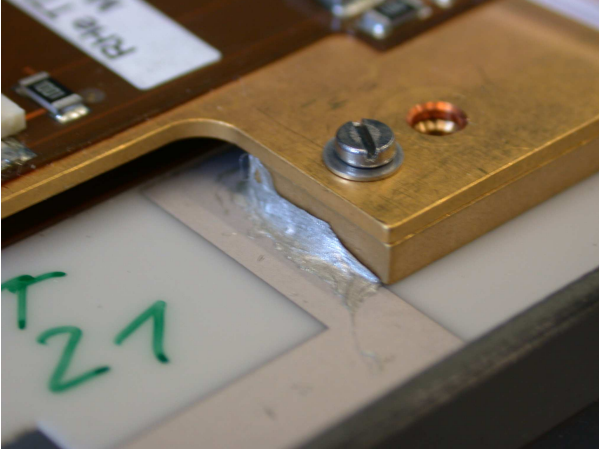
Conductive glue was used to connect the grounding of the TT readout hybrid to the cooling block of the sensor module and for the connection of the biasing voltage on the back side of each silicon sensor. While initial testing showed a good connection, older prototypes suffered from high glue resistances. The reason is due to the inability of the silver glue to stop the oxidization for the underlying aluminium [5]. In addition the grounding of the readout hybrid suffered from thermal cycling (Fig. 2). It was therefore decided to change the connection procedure for these locations. The grounding of the readout hybrids was changed to a screwed solder lug. As no soldering is possible on the back side of a silicon sensor, the bias lines of the Kapton supply cables were bonded to the sensor followed by a glob-top seal to protect the bond wires.

Figure 2: Breakup of silver glue after thermal cycling

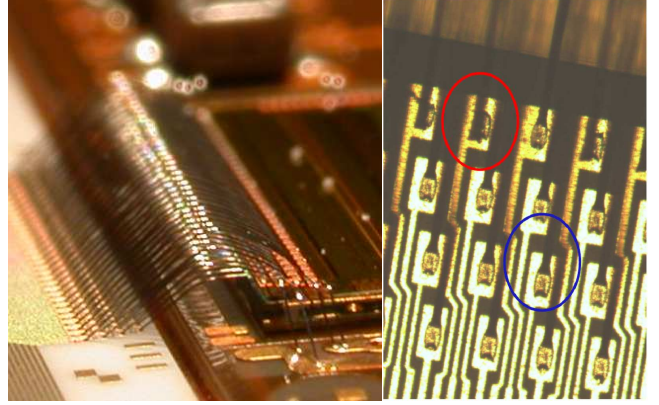
A problem that was discovered very recently concerns the wire bonds at the inputs of the Beetle front-end chips. As shown in Fig. 3, these are executed in four bond-rows to match the four-fold staggered input pads of the Beetle. A few weeks after the installation of the detector modules in the experiment it was found on six out of the 280 installed readout hybrids that a significant number of bonds in the inner-most of these bond rows were broken. Nothing similar had ever been observed in the extensive burn-in tests that each module had to pass during its construction and that were designed to reproduce conditions in the experiment as closely as possible. As of now, we have no explanation for this effect, investigations are ongoing.

Figure 3: 4-fold staggered bonding (left) and comparison of good vs. bad bond connections (right)

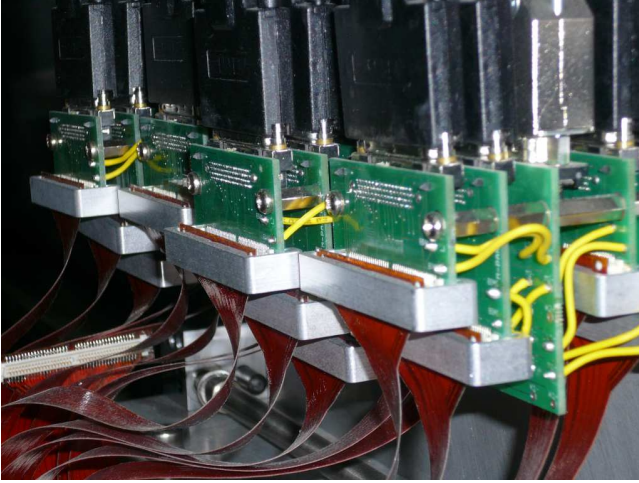
Each readout hybrid requires a single cable connection only, where all necessary supplies and signals are provided. An 80-pin high-density connector was chosen which connects on the Beetle readout hybrid inside the cold volume and to small patch panels outside. Due to the mechanical layout, the inner ends of the cables are guided by small gaps in the main cooling plate. Therefore no torque applies to this mating interface. As space is very limited on the outside between the feedthrough and the patchpanels, the cables had to be bent in tight radii to be mated to the patch panels. The resulting torque led in several cases to unreliable electrical connection between mated high-density connectors. To ensure a mechanical fix of this mating, milled aluminium clamps were designed which could be applied to the patch panel stack and improved the connection (Fig. 5).

Figure 4: machined aluminium clamps for securing the high-density connectors

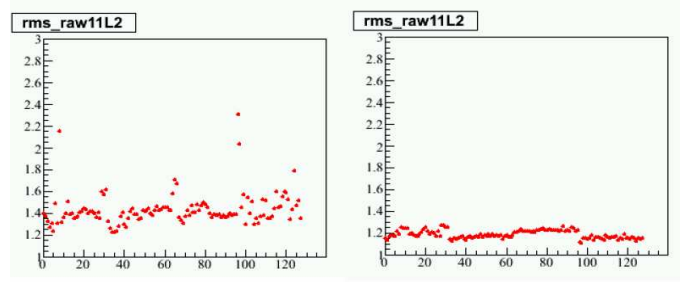
In early laboratory tests, a non-flat noise distribution within a analogue readout frame was discovered. As this distribution was persistent even without any attached readout chip, it was traced back to have its origin inside the Digitizer Board itself.

Figure 5: Comparison of raw noise without filter (left) and with filter (right)

In addition to the sampling rate, any ADC has a specified analogue bandwidth. Usually, this bandwidth exceeds the sampling rate to enable ‘undersampling’, i.e. to digitize a signal with a frequency larger than the sampling rate. To limit the amount of noise at the input of an ADC, a lowpass filter with a properly dimensioned cutoff frequency has to be used. While an early datasheet of the used ADC cited an analogue bandwidth of 100 MHz [6], an updated version listed a bandwidth of 1000 MHz [7]. Tests have shown that a 70 Mhz lowpass, which could be easily added to the existing layout, was sufficient to restore the required flat noise distribution (Fig. 6). This lowpass filter was fitted to all Digitizer Boards prior to installation in the detector.

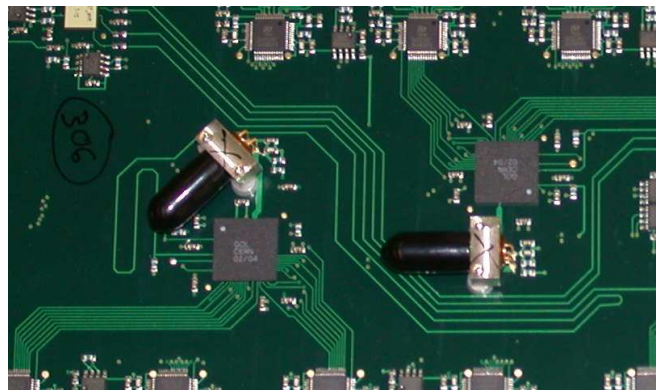
Figure 6: VCSEL diodes with receptacle next to GOL serializer

During reception tests of the production Digitizer Boards, 30 % of the VCSEL diodes were determined to be outside of the optical power specifications. Tests performed by the vendor confirmed a misalignment of the VCSEL diodes inside the metal receptacle. This problem was traced to the soldering procedure of the diodes, which were wave soldered. As the diodes were already fixed to the board via their screws, a large amount of heat was transferred through them into the receptacle which led to the weakening of the glue holding the

diode in alignment. As the preproduction boards were hand-soldered, this problem did not show up during the first batch of boards. A repair of these diodes was not possible and therefore all boards had to be screened and the defective diodes were individually replaced.

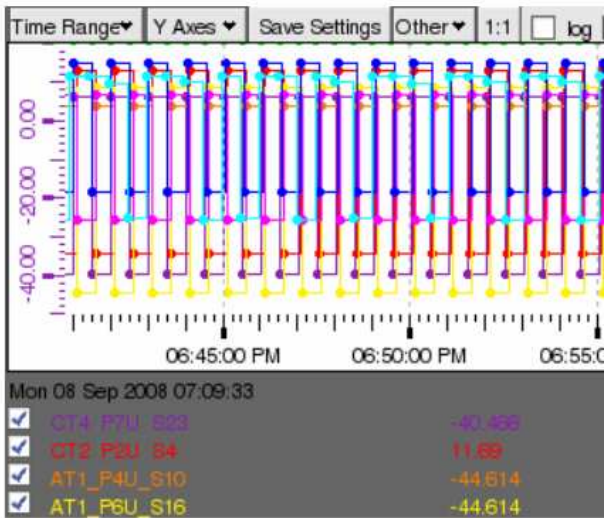
Each Beetle readout hybrid features a PT1000 resistive thermometer, which can be read out by its associated Digitizer Board. This is done via a DCUF slow control ADC [9]. After installation of the Service Boxes in the detector, all ADC readouts showed an oscillating odd-even behaviour (Fig. 8).

Figure 7: oscillating values from the DCUF slow control ADC

The source of this behaviour was determined to be an overvoltage condition on one of the other ADC input channels. An incorrectly dimensioned resistive divider resulted in an input voltage of 3.8 V, which is beyond specifications for a 2.5 V powered ADC. Once this resistive divider was corrected the DCUF readout worked as designed. The change of dividers has only been done for some Digitizer Boards corresponding to selected locations in the detector as this problem was understood only very late in the commissioning process. As these are non-critical readings, the dividers will be changed over time during normal maintenance and board replacements.
